**Flood Control Project Maintenance  
Levee Inspections****LMA District Cover Sheet****Spring 2014 Levee Inspection Results****Reclamation District No. 0765 Glide**

**Levee Inspection Report By Mile - Spring 2014**

Waterway	Bank	Unit Miles	Inspection Start/End	Inspector
Unit No. 01 Sacramento River	Right	1.74	03/03/2014 03/03/2014	Richard Willoughby

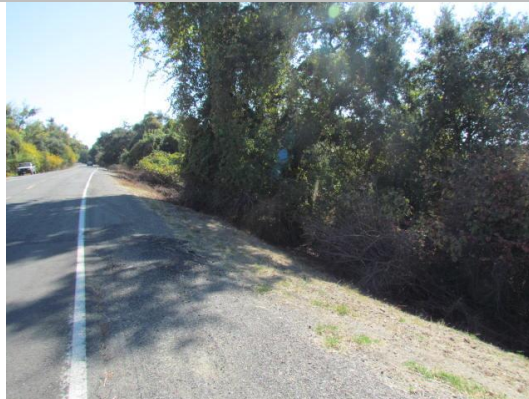
Photo 5 of 6 : richard\_s\_20140303\_083.jpg

LM Start	0.87	Rating **	A/W	Issue No.	17 (cont)
LM End	0.99	Issue Type +	Ma	Location *	LS
Category	Earthen Levee			GPS Latitude/Longitude	
				Start	End
Item	Trim / Thin Trees			38.491283 °	38.489771 °
				-121.556360 °	-121.555451 °
DWR ID	DWR_RD0765_01_s _ 2012_17				
Action/Comments					
Trim trees to at least five feet above ground level.

Looking southwest at dense vegetation on landward slope.

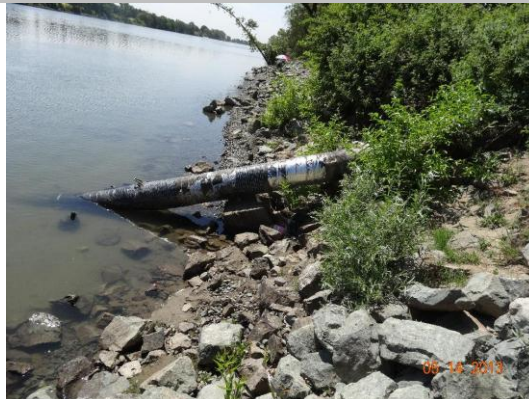
Photo 1 of 1 : UCIP\_1852.jpg

LM Start	0.96	Rating **	M	Issue No.	20
LM End	0.96	Issue Type +	En	Location *	LS
Category	Supplemental			GPS Latitude/Longitude	
				Start	End
Item	DWR UCIP Field Study			38.490127 °	38.490127 °
				-121.555594 °	-121.555594 °
DWR ID	DWR_RD0765_01_s _ 2014_20				
Action/Comments					
Inspector Comments: FS_ID:19579

Pipe section visible at waterward toe.

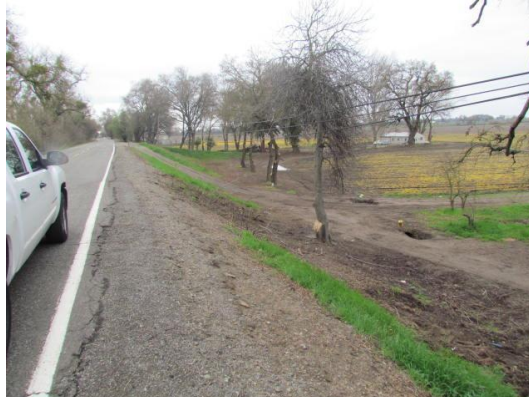
Photo 4 of 5 : richard\_s\_20140305\_142.jpg

LM Start	0.97	Rating **	A/W	Issue No.	81 (cont)
LM End	0.97	Issue Type +	Ma	Location *	LS
Category	Earthen Levee			GPS Latitude/Longitude	
				Start	End
Item	Vegetation			38.489962 °	38.489962 °
				-121.555573 °	-121.555573 °
DWR ID	DWR_RD0765_01_s _ 2012_81				
Action/Comments					
Remove the wild growth other than native grasses from the levee

Looking southwest at trimmed trees and vegetation on landside slope and toe.

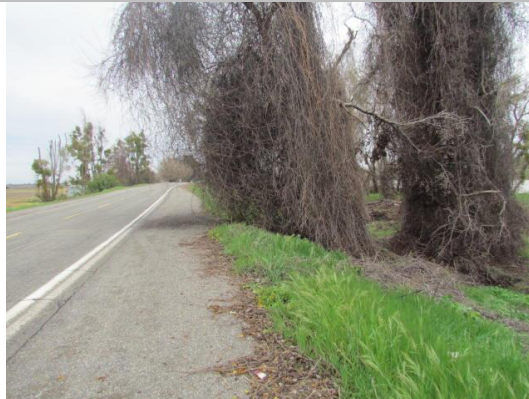
Photo 1 of 1 : richard\_s\_20140305\_132.jpg

LM Start	1.41	Rating **	M	Issue No.	4
LM End	1.41	Issue Type +	Ma	Location *	WS
Category	Earthen Levee			GPS Latitude/Longitude	
				Start	End
Item	Trim / Thin Trees			38.484316 °	38.484316 °
				-121.552115 °	-121.552115 °
DWR ID	DWR_RD0765_01_s_2012_4				
Action/Comments					
Trim trees to at least five feet above ground level.

Looking north at untrimmed trees on waterward slope.

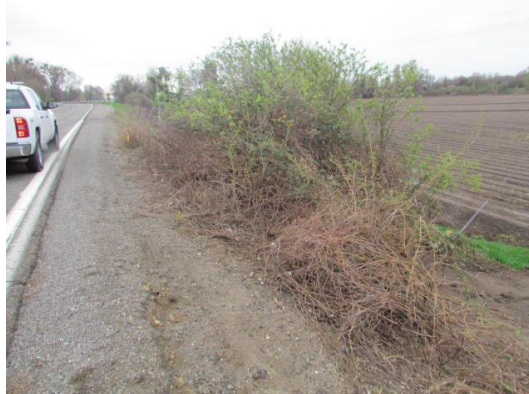
Photo 4 of 5 : richard\_s\_20140305\_145.jpg

LM Start	1.54	Rating **	M	Issue No.	29 (cont)
LM End	1.54	Issue Type +	Ma	Location *	LS
Category	Earthen Levee			GPS Latitude/Longitude	
				Start	End
Item	Trim / Thin Trees			38.482665 °	38.482665 °
				-121.551036 °	-121.551036 °
DWR ID	DWR_RD0765_01_s _ 2012_29				
Action/Comments					
Trim trees to at least five feet above ground level.

Looking southwest at vegetation on landside slope.

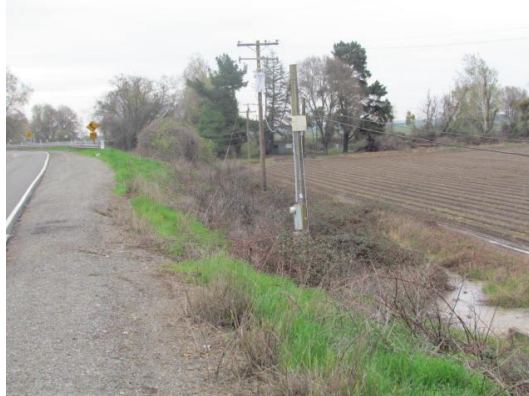
Photo 5 of 5 : richard\_s\_20140305\_146.jpg

LM Start	<b>1.54</b>	Rating **	M	Issue No.	<b>29 (cont)</b>
LM End	<b>1.54</b>	Issue Type +	Ma	Location *	LS

Looking southwest at berryvines on landside slope.

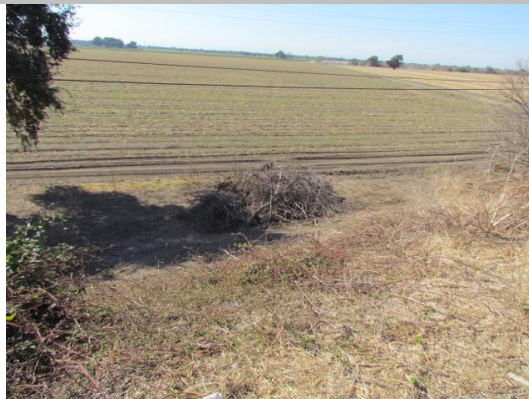
Photo 1 of 1 : richard\_s\_20140303\_115.jpg

LM Start	1.56	Rating **	A/W	Issue No.	59
LM End	1.56	Issue Type +	Ma	Location *	LS
Category	Earthen Levee			GPS Latitude/Longitude	
				Start	End
Item	Encroachments			38.482402 °	38.482402 °
				-121.550867 °	-121.550867 °
DWR ID	DWR_RD0765_01_f _ 2013_59				
Action/Comments					
Prunings

Looking west a prunings on landward berm.
